齿轮测量与结果解读

石照耀 博士

2019.1.12

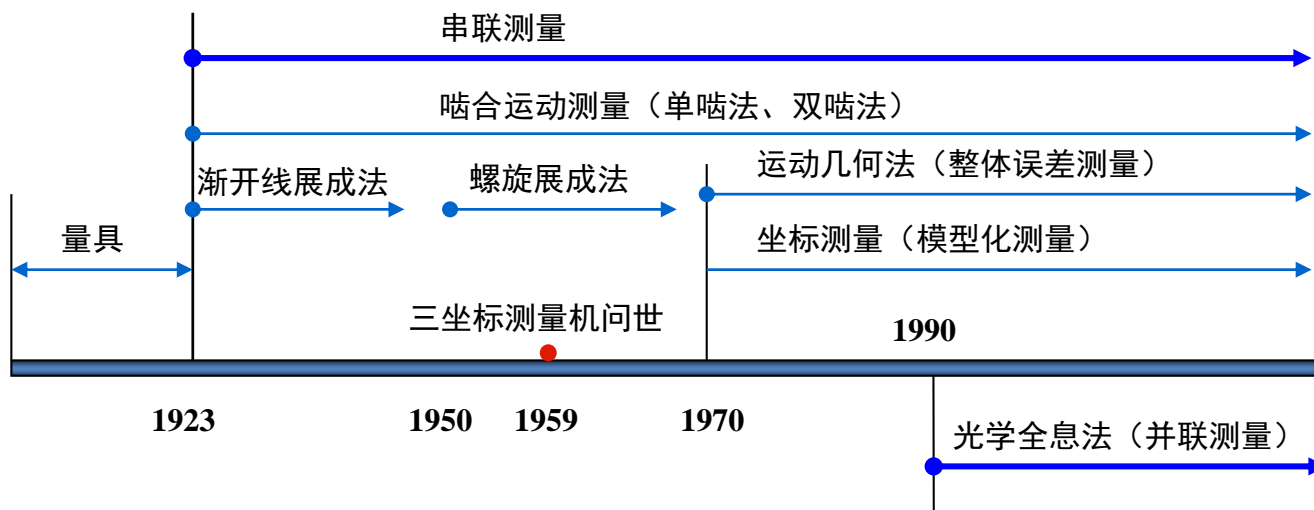
齿轮测量方法的发展

1970年是齿轮测量技术的转折点。齿轮测量中心和齿轮整体误差测量技术的出现解决了齿轮测量领域的难题，即在一台仪器上快速获取齿轮的全部误差信息。这两项技术虽然都基于现代光、机、电、计算机等技术，但走上了不同的技术路线。

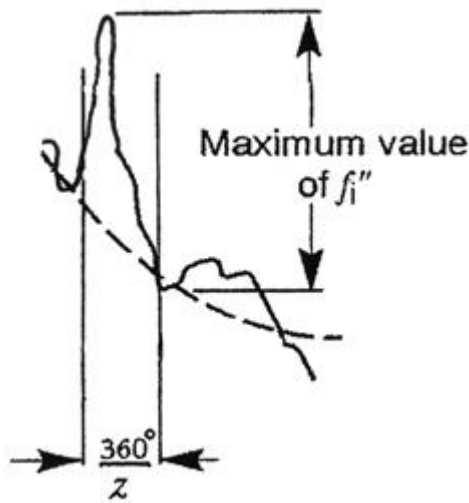
情况1: Large f_i'' and Uniform Tooth-to-Tooth Errors

- 1) The large f_i'' is typically a dirty condition or a nick on a gear tooth. Nicks are normally caused by material handling problems. Adding a tip chamfer to the design of the gear tooth profile, and hob, will reduce this type of damage.

2) A uniform but excessive tooth-to-tooth error that repeats each $360^\circ/Z$ (where z is the number of teeth in the part) is typically caused by the cutting tool and involute error.

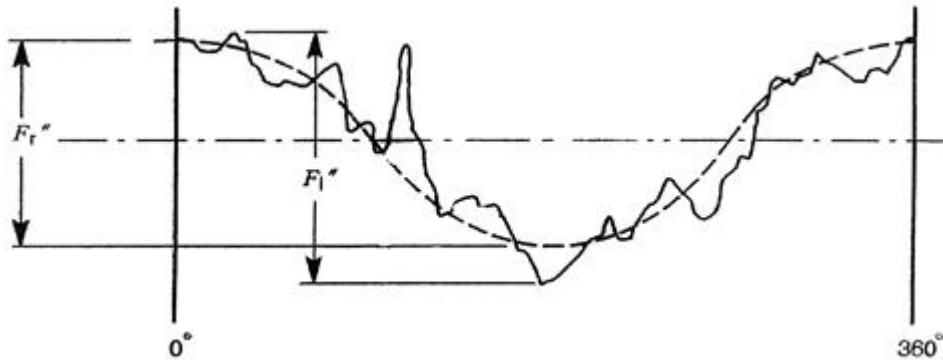
情况3, F_i'' 大

- 1) The work piece blank has radial run-out or the blank has face wobble, resulting in excessive axial runout.
- 2) The work piece mounting fixture has radial or axial runout.
- 3) The gear teeth have excessive lead variation.
- 4) The hobbing machine work spindle or index drive system is worn or has runout.

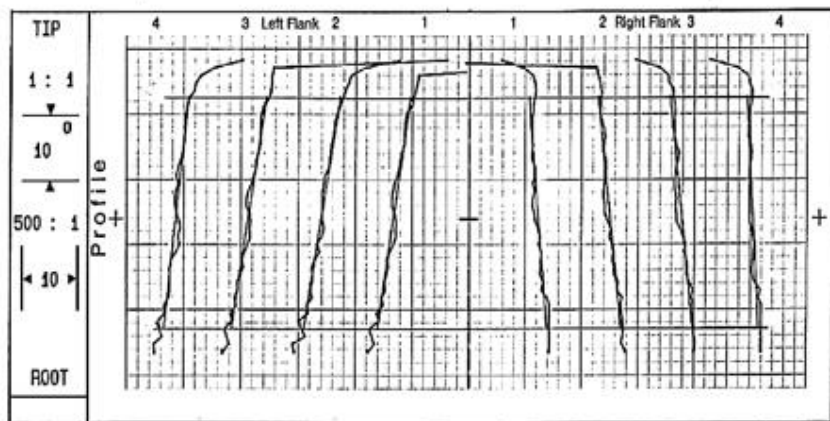
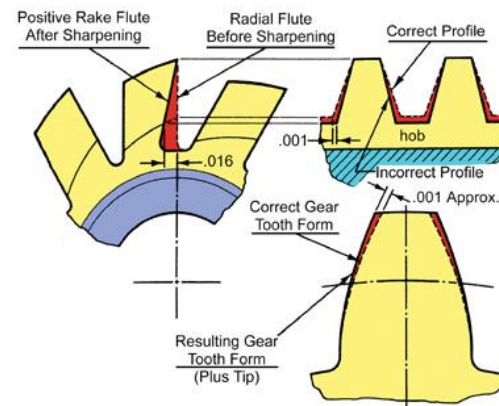
Figure 7: Profile Inspection with negative tip tooth

1) Incorrect hob sharpening. The hob has been sharpened with positive rake error making the hob tooth larger toward the outside diameter and the gear tooth smaller.

2) Incorrect swivel angle setting on the hobbing machine.

3) Bad hob.

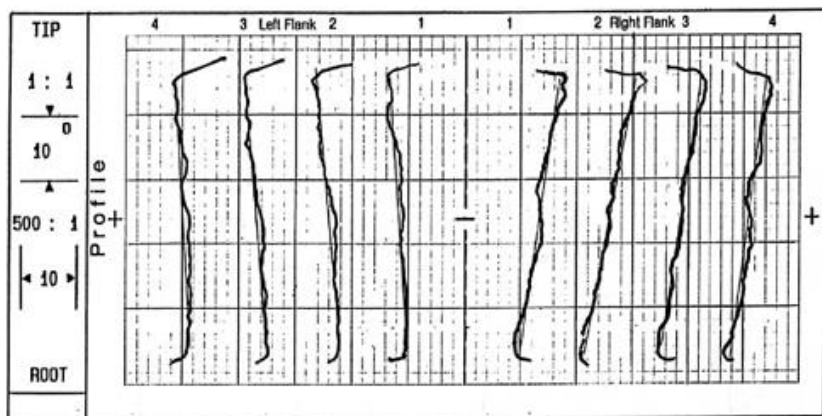
Figure 9: Profile inspection with positive tip

- 1) Incorrect hob sharpening. The hob has been sharpened with negative rake error, making the hob tooth smaller toward the outside diameter with gear tooth larger. This is the opposite of the condition shown in Figure 8.
- 2) Incorrect swivel angle setting on the hobbing machine.
- 3) Bad hob.

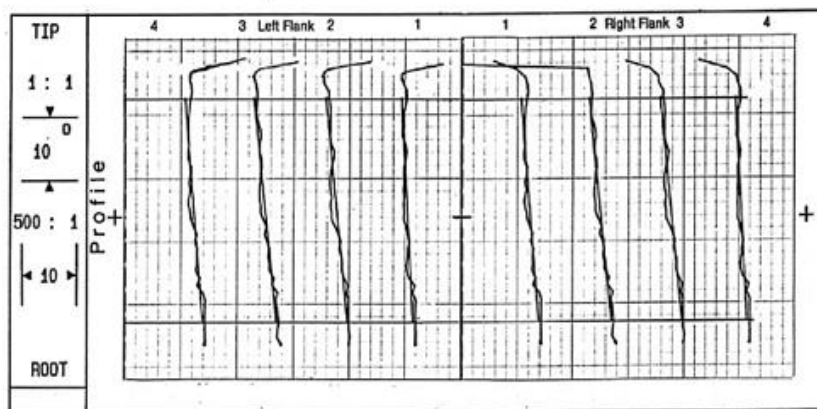
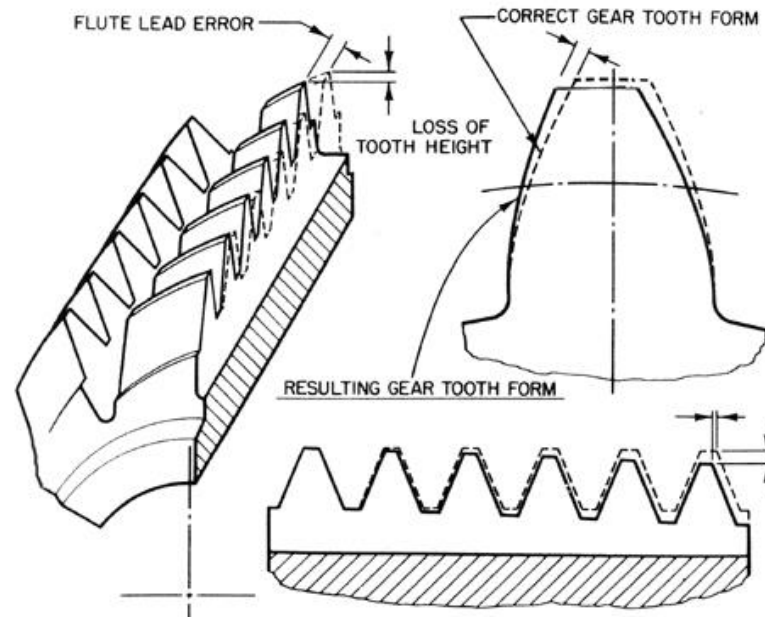
Profile inspection with leaning teeth

- 1) Incorrect hob sharpening. A hob sharpened with gash lead error will cause both a leaning profile and size change as the hob is shifted. See Figure 2.
- 2) Loose hob head swivel on the hobbing machine.

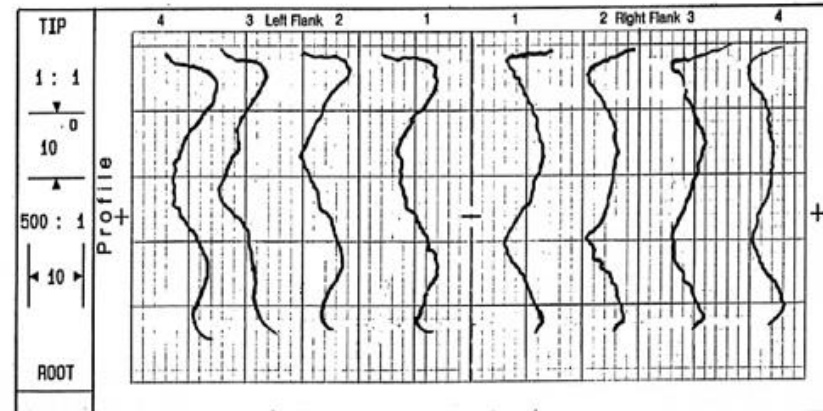
Profile inspection with uniform wave

- 1) Hob had runout when mounted. The hob run-out can be caused by a bad cutter, damaged arbor, or dirty mounting conditions.
- 2) Incorrect hob sharpening. The hob was sharpened with runout during the mounting on the sharpening machine or sharpening

arbor. Extreme gash to gash spacing error on the hob.

- 3) A loose or worn hob arbor end support on the hobbing machine.
- 4) Excessive backlash in the hob spindle system on the hobbing machine.
- 5) Excessive backlash in the work spindle system on the hobbing machine.

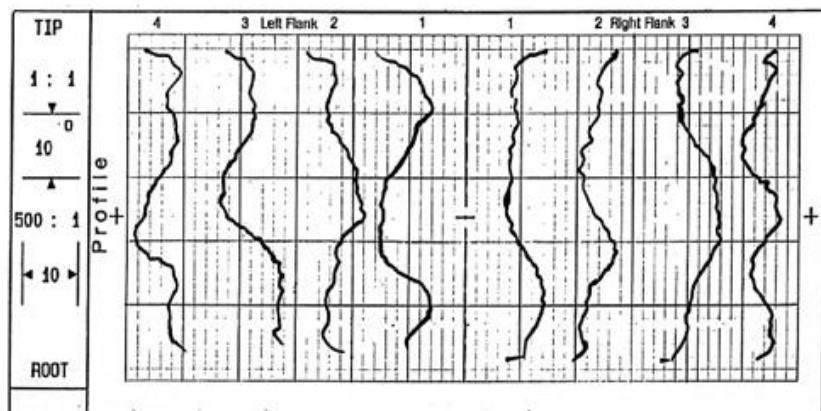
Profile inspection with non-uniform wave

- 1) A loose or worn hob arbor end support on the hobbing machine.
- 2) Excessive backlash in the hob spindle system on the hobbing machine.
- 3) Excessive backlash in the work spindle system on the hobbing machine.
- 4) Hobbing machine system in poor overall condition.

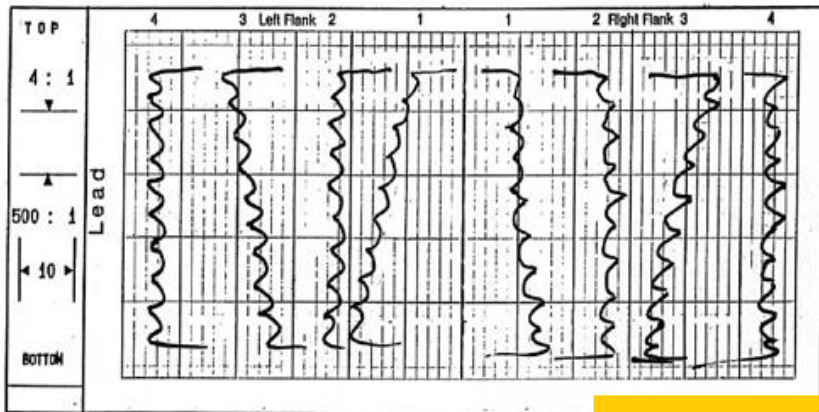
Figure 13: Helix inspection with wobble

- 1) Part blank bore not perpendicular to the face of the blank.
- 2) Part blank faces not parallel.
- 3) Fixture not accurate, or misaligned.
- 4) Tailstock misaligned, or center loose or damaged on the hobbing machine.
- 5) Inspection arbor problem.
- 6) Worm spindle bearing problem on the hobbing machine.

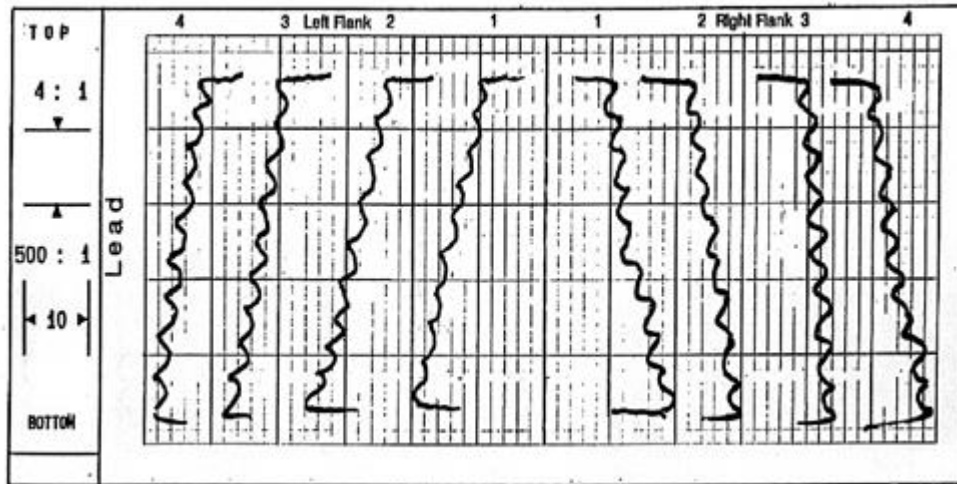
Figure 14: Helix inspection with taper

- 1) Tailstock misaligned on the hobbing machine.
- 2) Hobbing machine misaligned.

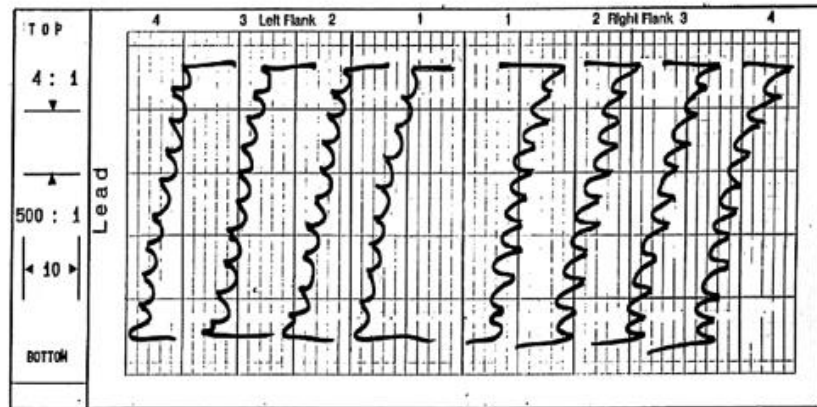
Figure 15: Helix inspection with angular error

- 1) Tailstock misaligned on the hobbing machine.
- 2) Hobbing machine misaligned.
- 3) Incorrect differential change gears or helix value (CNC).
- 4) Loose or work hob arbor end support on the hobbing machine.
- 5) Incorrect helix checking machine settings.

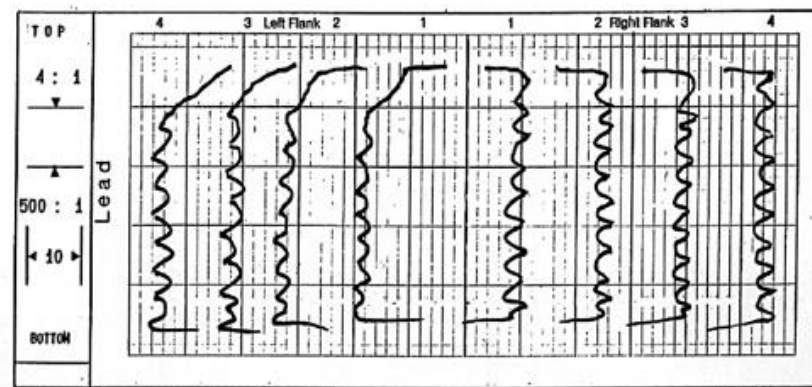
Figure 16: Helix inspection with breakout error

- 1) Tailstock loose or worn.
- 2) Part slipped in the fixture.
- 3) Fixture not clamped properly.
- 4) Hob arbor end support improperly installed or worn on the hobbing machine.
- 5) Hob saddle gibs out of adjustment.
- 6) Backlash in the cutter spindle drive system on the hobbing machine.
- 7) Backlash in the work spindle drive system on the hobbing machine.

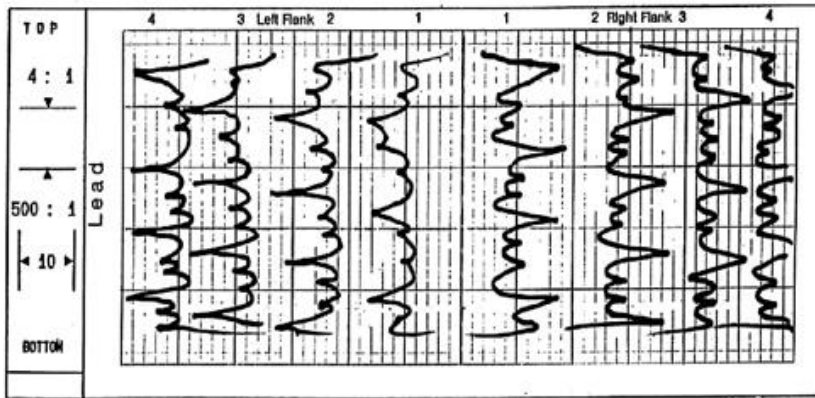
Figure 17: Helix inspection with periodic error

- 1) Runout of multiple thread hob.
- 2) Thread to thread spacing error on multiple thread hob.
- 3) Feed screw or bearings of the feed screw on the hobbing machine.
